Lottice Brook Restoration and Wetland creation at Brookside

Ribble Rivers Trust RRT178

Date: 12/08/2025

Authored by: Abigail Gunson – Project officer

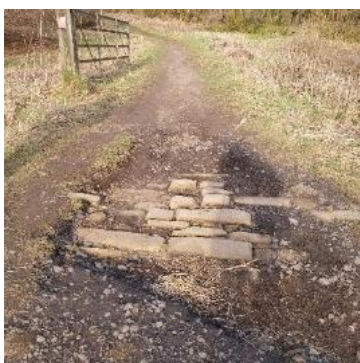
The bridge crossing at the centre of the brook (figure 2) is a major access point for visitors of the reserve but is prone to flooding. Over time it has become uneven because of water flooding out of the brook as well as the path to the north, this has resulted in the erosion of previous attempts to level out the path.

Figure 2 - Crossing over Lottice Brook

There is potential for the construction of an overflow channel or swale on the east side of the path reaches the brook and instead redirecting the water to a depression on the left-hand bank of the brook (marked in this extract from Scalgo live) where there is already evidence of a flow path through the vegetation (figure 3) that leads into the brook.

This opportunity would reduce the risk of further degradation of the crossing, filling the depression in times of flood. This would allow the surface of the crossing to be repaired and improve accessibility of the site to wheelchair users, prams and those with mobility issues. However, this would only influence water running from the top of Stanhill road and the channel flood water may ultimately continue to flow over the bridge and cause similar issues.

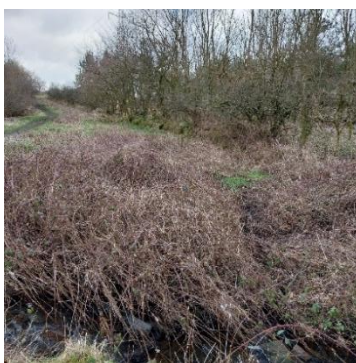
Figure 3 - Evidence of flow path into the brook

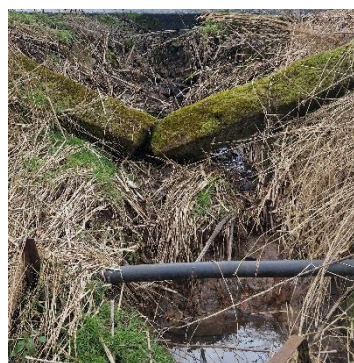
An overflow channel might also be beneficial at points of the reservoir that flood over the side of the reservoir bunds. The water can then be redirected to the potential floodplain or wetland areas rather than left to chance.

Figure 4 - flooding over reservoir sides

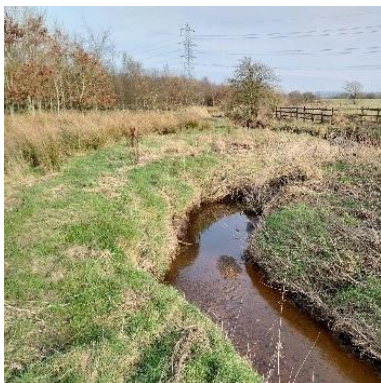
Figure 6 SD71759 27180

The first opportunity presents itself immediately by the motorway outfall where the channel has revetments and a laid bed. The water quality in this area is poor and likely has little ability to regulate water levels during high flow events. The land on the left-hand side of the brook has the potential for wetland creation with three flow paths entering from Lottice brook and flat surface area with no obvious sandy or gravelly soil although testing the soil properties would help determine its current and potential water retention capacity. A wetland in this area would likely address water quality and flood storage issues, and improve the quality of water downstream. The Lancashire Wildlife Trust have suggested that tiered filtration bed with planted *Phragmites* and *Typha* could be an effective solution to take in excess rainwater and filter the motorway runoff before the water enters the brook. A potential challenge to the creation of a wetland area here would be the lack of space and natural depressions in the area, which would limit the ability of the area to naturally collect and hold significant volumes of water which would ultimately maintain the wetland habitat.

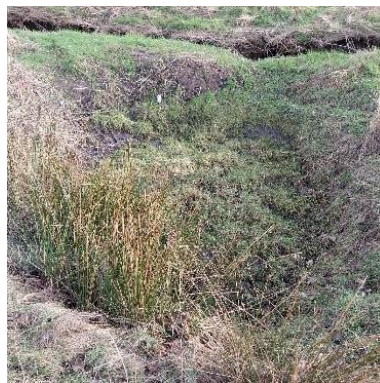
Figure 7 SD71892 27219

The third area for a potential wetland is located by an obvious depression on the left-hand bank of the brook. The land is generally quite flat and already supports a population of basic wetland vegetation (*Juncus*) as well as having a natural depression that already functions to hold water from the flow paths. The potential also extends into the established woodland. The size drawn on the map is more of an estimate and is likely unrealistic for any initial wetland creation as the flow path veers slightly more east to where the depression is so without the additional input of water it is unlikely it would be regularly flooded to the extent of a wetland.

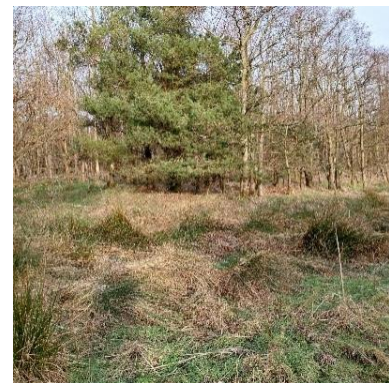
Figure 8 SD72236 27264

W4 has been suggested as a potential wetland/wet woodland stretch as it has a few suitable wetland features including wet/inundated ground, multiple flow paths and wetland vegetation. The area would also benefit from wetland creation as the brook channel has stone revetments on

both banks which reduce its flood water storage capabilities and small volumes of seepage from the lodges which likely influences the quality of the water in the brook.

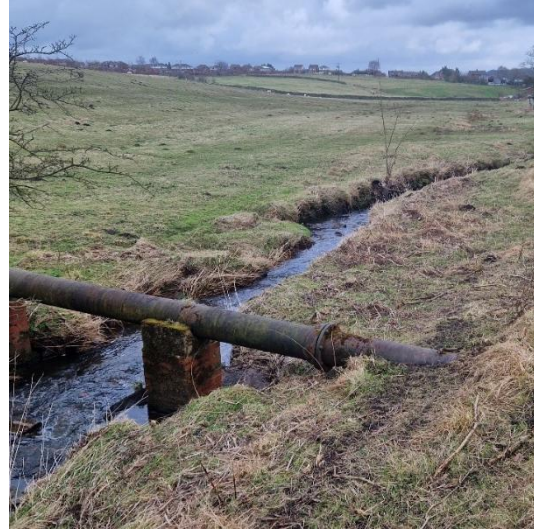
Figure 13 SD72648 27211

The third opportunity lies just outside of the Brookside Climate Action area of work however it is worth highlighting that the field has the potential to be enhanced for the benefit of the project and the landowner. Between F2 and F3 there are revetments lining both banks of the channel; however, the channel itself is meandering and the land on the left-hand bank is already a connected, low-lying floodplain. There is potential to improve the condition of the floodplain by removing the revetments, planting native wet vegetation, potentially fencing the area off from stock, and enhancing the land into a habitat corridor.

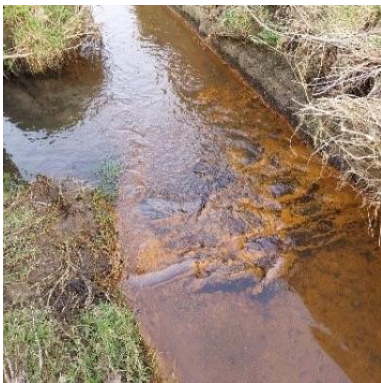
Figure 15 SD71759 27180

Several sections along Lottice brook are lined with stone wall and bed revetments that inhibits the natural shape and flow of the watercourse. Some of the sections of the watercourse would benefit from the removal of the revetments (see the provided map for opportunities for removal).

The removal of these revetments would reconnect the watercourse with its associated floodplain and ultimately improve the functionality of the brook's natural flood management. It would also encourage the re-meandering of the brook into a more natural state and introduce some variability to the flow.

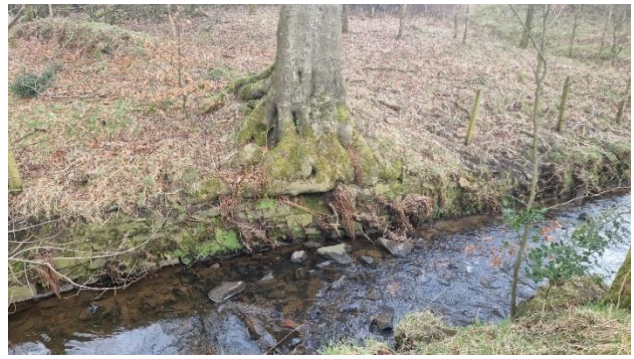
It should be noted that some locations will not be viable for revetment removal. There may be historical value or complications due to the presence of mature trees and culverts, so alternative actions may need to be considered in these areas.

Figure 18 SD72340 27220, Example of revetment location where removal will not be viable.

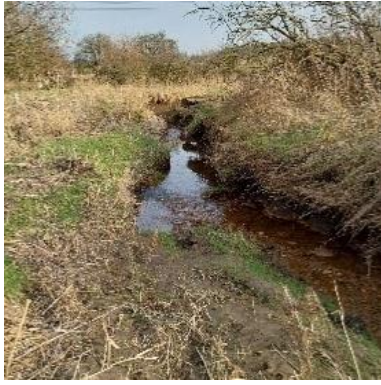
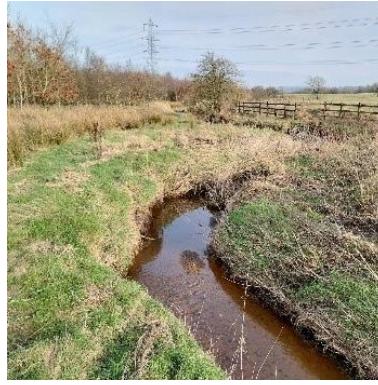
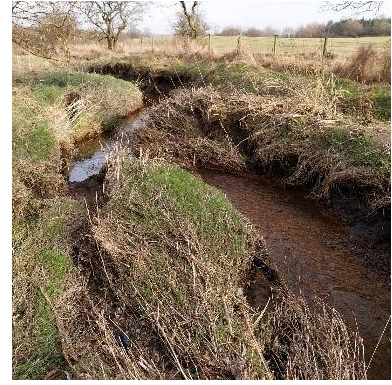
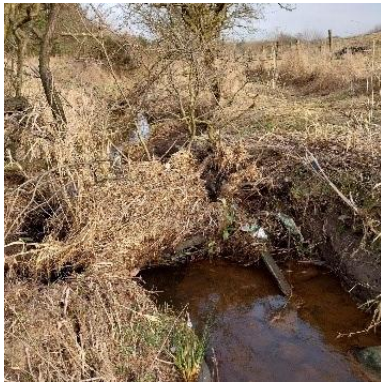
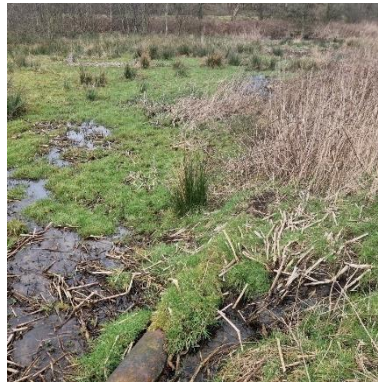
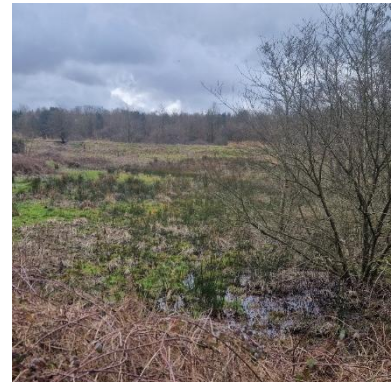
There are some sections of the river that exhibit some degree of natural recovery without human influence. These are areas where there are no structures such as wall revetments and where trees and woody debris have fallen into the river, the natural process that the previously mentioned leaky dams mimic.

In one instance, by the eastern reservoir, pipes and eroded structures have, over time, held back enough water for the area around it to become seasonally inundated with water and develop wetland/fen characteristics. Some natural remeandering is also taking place along sections of the brook.

Evidence of natural recovery

In these areas, doing nothing with the watercourse may be the most beneficial option given that it is seemingly changing for the better without human intervention. Allowing the habitat to naturally recover would cost nothing and additionally would not produce any construction-related carbon-emissions or disturbance to the ecology or geology of the watercourse or the surrounding land.

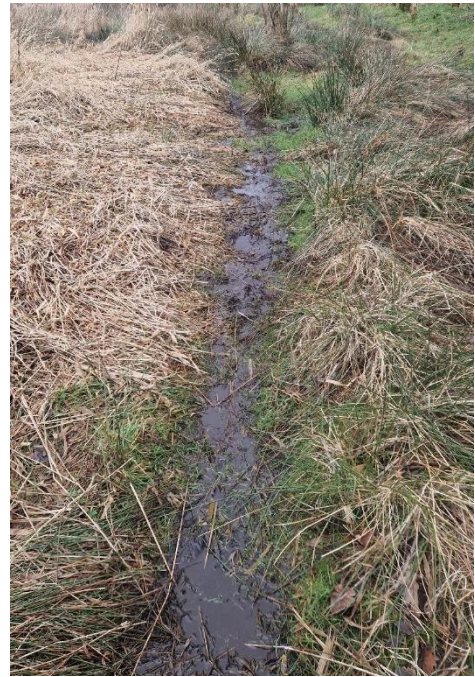
The footpath behind the reservoir is regularly inundated with water and overgrown with vegetation, making it less accessible to visitors of the site. Additionally, the bridge crossing at the bottom of Stanhill road (mentioned in the overflow channel/swale section) has eroded and become uneven, and as the main entrance to the site for those with mobility issues, it has become a cause for concern. Other areas of crossing for walkers are either unintentionally created (ie desire lines and dog tracks) or unstable (loose stone cobbles). There is also no official crossing for horse riders, which has led to high volumes of foot traffic through the river.

Figure 27 Footpath behind reservoir

A number of different options can be considered here. A wooden boardwalk could be installed to replace the footpath behind the reservoir. the boardwalk would be elevated so that during periods when the ground is flooded, the route is still useable by visitors. This would also allow the habitat around the boardwalk to remain a wet area without inhibiting the use of the site by visitors.

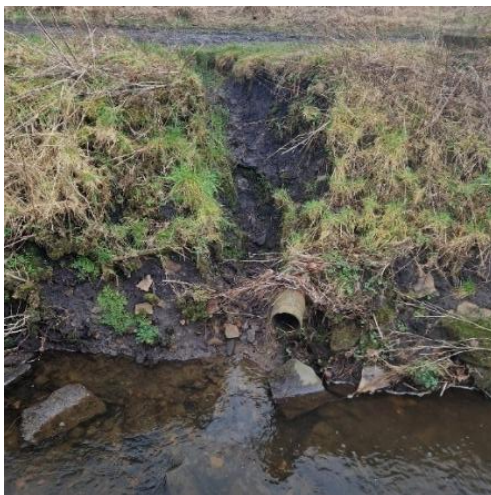
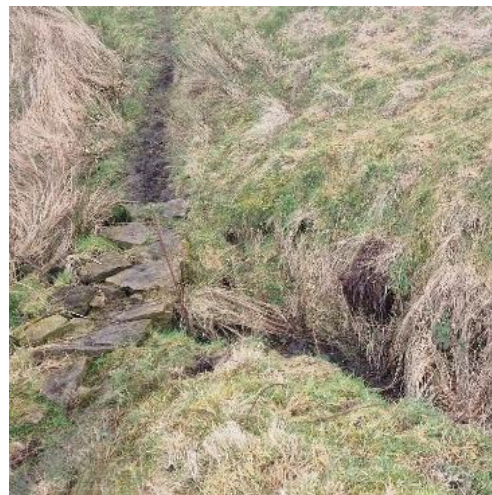
Areas of potential footpaths

Finally, a track can potentially be dug out and stabilised upstream where the banks have already eroded because of regular foot traffic. This path would hopefully encourage visitors to cross at this designated location to minimise the damage along the entire length of the brook.

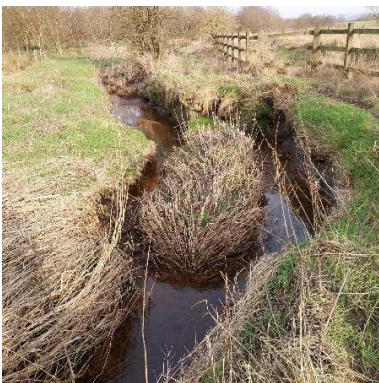
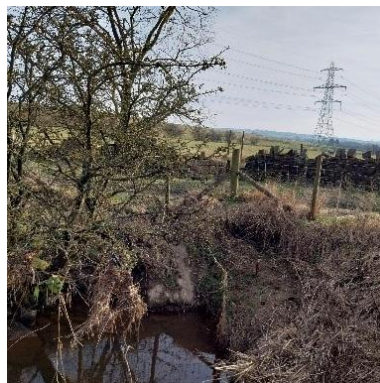
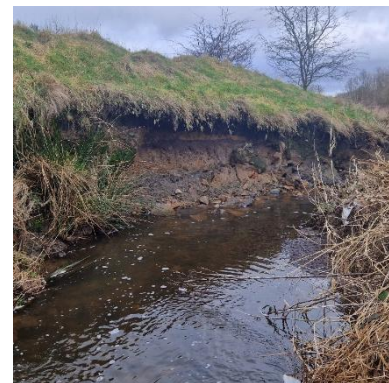
At certain sections of the brook, the bank has eroded very close to the fence/path which poses a risk to the safety and stability of the main footpath. The below figure identifies locations where the distance between the brook and the footpath is 5 metres or less, and as such any further erosion could eat into the footpath.

Locations of active erosion

Interventions such as willow staking and brash bundles would be suitable to mitigate any further erosion of the bank as the roots would stabilise the bank edges. Overtime the willow and brash material will improve the integrity of the banks and reduce the risk of further erosion.

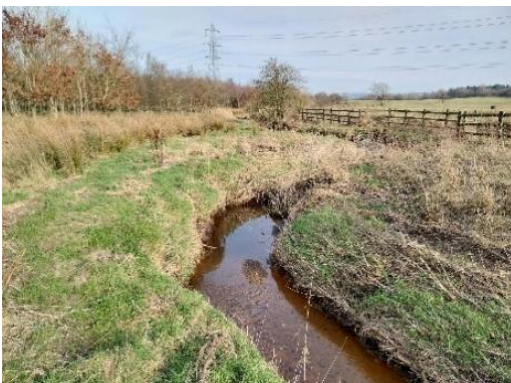
Figure 37 image showing the colour of the brook just after the motorway outfall. on the left-hand bank is the area for potential wetland

Wetland 1 – this is located by the motorway and septic tank outfall into Lottice Brook. The fundamental service that this wetland will provide will be filtration. The treatment wetland will intercept the points at which pollution runs into the brook, at the upstream end of the brook before running through brookside. This would be significant for the overall quality of the brook and relieve the pressure of any downstream flood mitigation by storing flood water and improving the capacity for Lottice brook to regulate excess water.

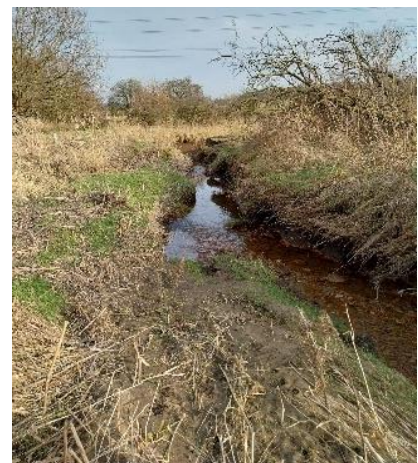
Figure 43 partially formed 2-stage channel

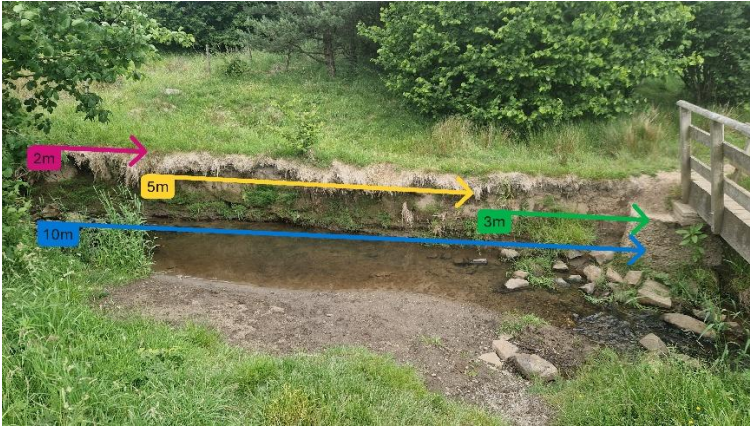
Figure 44 Suggested dimensions for cliff reprofiling

Cliff reprofile – A steeply eroded section of the left-hand bank could be reprofiled to provide a more accessible crossing for horse riders as well as mitigate for any future collapse.
