Lottice Brook Restoration and Wetland creation at Brookside

Ribble Rivers Trust RRT178

Date: 12/08/2025

Authored by: Abigail Gunson – Project officer

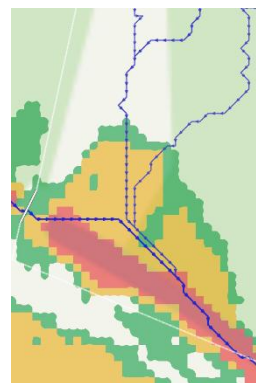
The bridge crossing at the centre of the brook (figure 2) is a major access point for visitors of the reserve but is prone to flooding. Over time it has become uneven because of water flooding out of the brook as well as the path to the north, this has resulted in the erosion of previous attempts to level out the path.

There is potential for the construction of an overflow channel or swale on the east side of the path reaches the brook and instead redirecting the water to a depression on the left-hand bank of the brook (marked in this extract from Scalgo live) where there is already evidence of a flow path through the vegetation (figure 3) that leads into the brook.

This opportunity would reduce the risk of further degradation of the crossing, filling the depression in times of flood. This would allow the surface of the crossing to be repaired and improve accessibility of the site to wheelchair users, prams and those with mobility issues. However, this would only influence water running from the top of Stanhill road and the channel flood water may ultimately continue to flow over the bridge and cause similar issues.

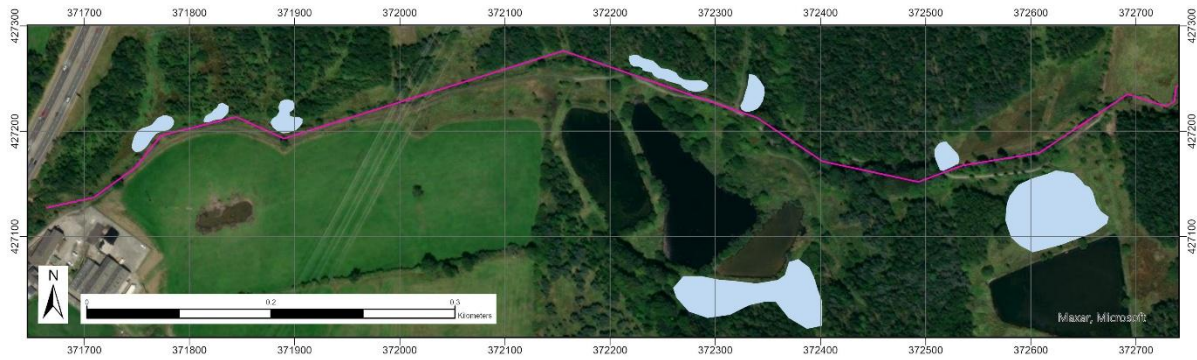
Figure 5 Wetland opportunities

There are several areas along the brook with wet conditions and a significant presence of rush (*Juncus*). This presents the opportunity for wetland creation in these areas of prolonged boggy ground conditions, depressions adjacent to the brook and vegetation that can survive in waterlogged soil and subsequently enrich it.

Establishing wetlands will enhance the current riparian habitat and allow these areas to support a wider variety of vegetation and wildlife. An additional bonus to wetland vegetation is the natural filtration, which would then improve the quality of water. It would also function as additional water storage during heavy rainfall and flood events, providing an element of natural flood management.

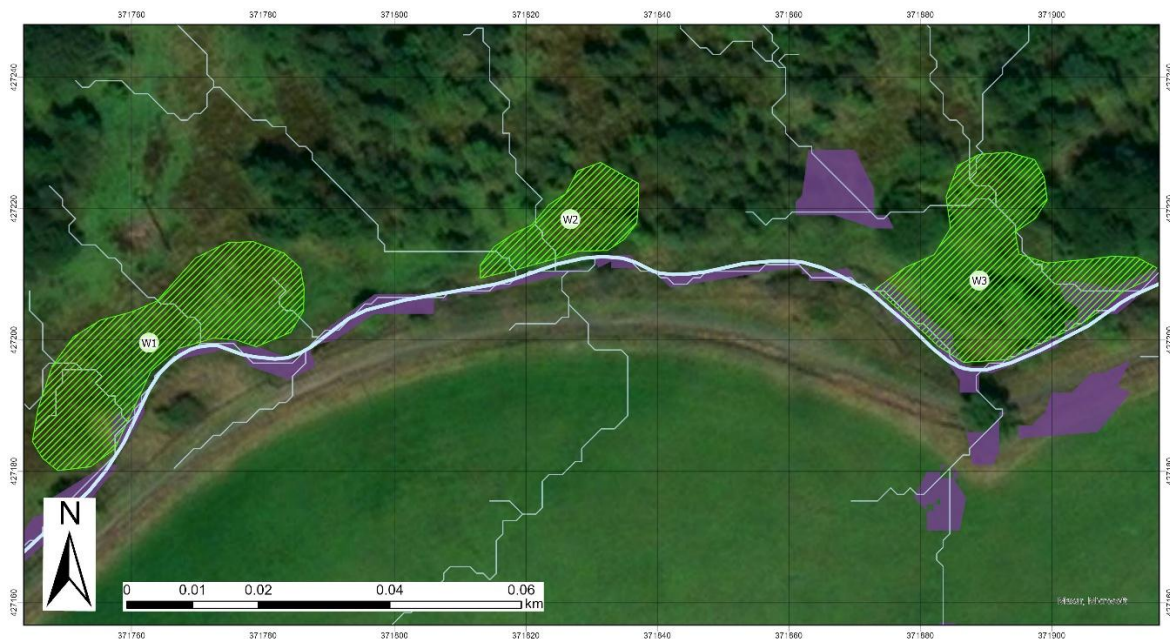
Figure 9 Map of wetland opportunities: Wetland 1 (W1), Wetland 2 (W2), Wetland 3 (W3). Thinner blue lines represent flow paths into Lottice Brook (Thicker line), data collected from SCALGO live. Purple shapes represent depressions in the ground.

The first opportunity presents itself immediately by the motorway outfall where the channel has revetments and a laid bed. The water quality in this area is poor and likely has little ability to regulate water levels during high flow events. The land on the left-hand side of the brook has the potential for wetland creation with three flow paths entering from Lottice brook and flat surface area with no obvious sandy or gravelly soil although testing the soil properties would help determine its current and potential water retention capacity. A wetland in this area would likely address water quality and flood storage issues, and improve the quality of water downstream. The Lancashire Wildlife Trust have suggested that tiered filtration bed with planted *Phragmites* and *Typha* could be an effective solution to take in excess rainwater and filter the motorway runoff before the water enters the brook. A potential challenge to the creation of a wetland area here would be the lack of space and natural depressions in the area, which would limit the ability of the area to naturally collect and hold significant volumes of water which would ultimately maintain the wetland habitat.

Downstream of W1 there is a small area that was observed to have some degree of water retention. This would support the creation of a small, wooded wetland that would benefit the quality of the water in the brook, especially given that just upstream of this location there was a second drainage outfall with signs of sewage fungus. Later in this report there will be a

The third area for a potential wetland is located by an obvious depression on the left-hand bank of the brook. The land is generally quite flat and already supports a population of basic wetland vegetation (*Juncus*) as well as having a natural depression that already functions to hold water from the flow paths. The potential also extends into the established woodland. The size drawn on the map is more of an estimate and is likely unrealistic for any initial wetland creation as the flow path veers slightly more east to where the depression is so without the additional input of water it is unlikely it would be regularly flooded to the extent of a wetland.

recommendation of a 2-stage channel just upstream of W2 which could pair well with a small wetland to help store more water from the brook. Similar to W1, W2 does not have any natural depressions so could potentially struggle to hold significant volumes of water as well as having some observed sandy qualities to the soil adjacent to the brook that would make water retention difficult.

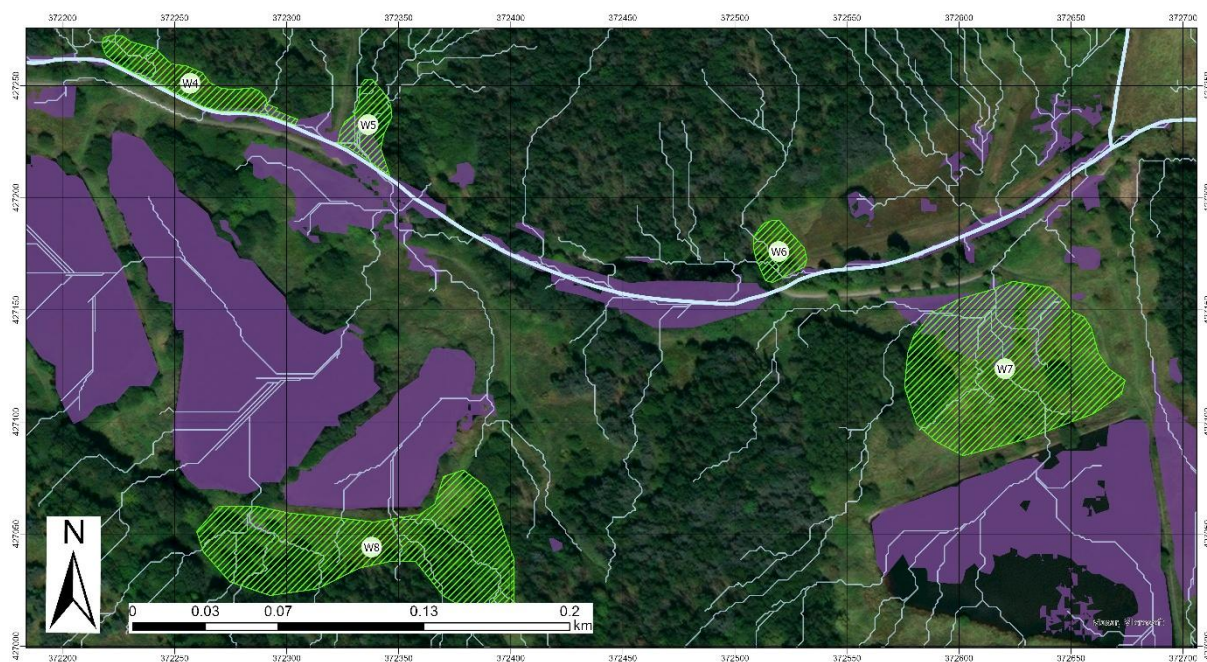
Figure 10 Map of wetland opportunities: wetland 4 (W4), Wetland 5 (W5), Wetland 6 (W6), Wetland 7 (W7) and Wetland 8 (W8). Thinner blue lines represent flow paths into Lottice Brook (Thicker line), data collected from SCALGO live. Purple shapes represent depressions in the ground.

W4 has been suggested as a potential wetland/wet woodland stretch as it has a few suitable wetland features including wet/inundated ground, multiple flow paths and wetland vegetation. The area would also benefit from wetland creation as the brook channel has stone revetments on

both banks which reduce its flood water storage capabilities and small volumes of seepage from the lodges which likely influences the quality of the water in the brook.

Adjacent to the path coming from Stanhill road, there is a depression in the ground as well as evidence of flow paths leading into the brook. An overflow channel has already been recommended for this location, but the creation of a wetland would be an additional benefit, subsequently improving the water storage properties in the area and would then further reduce the erosion of the bridge by storing the excess water from the new channel and the brook during flooding events.

W6 is located just before the smaller of the two drained reservoirs that are rarely inundated with water during dry periods. The smaller reservoir is dominated by Reedmace and provides a valuable habitat for invertebrates. The addition of an accompanying wetland could potentially mediate the reedmace dominated habitat and introduce a higher diversity of wetland vegetation by redirecting and holding additional water from the flow path to the west of the reservoir.

This area is already an overflow area for the large reservoir to the east that is regularly inundated with water spilling over from the reservoir. The area exhibits characteristics of a fen habitat or, at the least the potential for one: waterlogged soil, rushes and reeds, marsh vegetation such as southern marsh orchid, marsh marigold and common valerian. This area can be enhanced by removing strips of silt and adding natural material to increase the area of wetness as well as cutting and removal of vegetation on the embankments to restore species richness of positive indicator herbs such as heath bedstraw and bilberry. If the intention with this area is to allow succession/natural processes to take place it is likely to become a wet woodland or willow scrub overtime. The reservoir has been surveyed by the Lancashire Wildlife Trust and considered to be in poor shape. There is overflow from a raised manhole tower, which contribute to a significant volume of excess water. There is also a small area within the highlighted section for W7 that has been recorded to be permanently dry acid grassland (grid reference SD 72639 27152) that would benefit from remaining dry, so the proposed wetland should function to also redirect water from this area.

Like W7, W8 is already regularly inundated with water and has fen-like characteristics. The major issue with this area is the poor quality of the water that feeds it, both from the lodge adjacent to it but also from a small spring that seems to be rich in iron oxide. Creating more open wetland by digging out slits and relocating the soil into the riparian woodland as well as planting filtering vegetation such as *Phragmites australis* could help improve the quality of the water and enhance the condition of the wetland itself. Concerns have been raised by members of the public and partners of the project about the stability of the ground in this section as there are several exposed/collapsed drains that are quite deep, this might make it unfeasible for machinery to access the location or could increase the risk of injury to the general public.

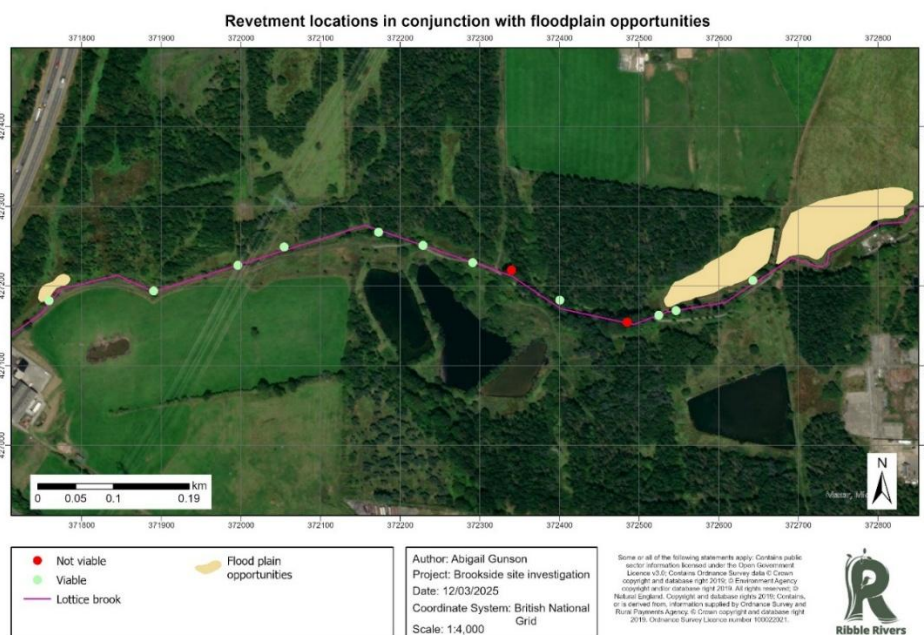
Figure 11 Map indicating points along Lottice Brook with revetments and associated potential floodplains

The drained and defunct reservoir is periodically inundated with water by both the brook, during flooding events, and a natural spring in a field to the north that floods the footpath in extensive rainfall. It also supports populations of various riparian vegetative species. The raised bunds have become less species rich over time but have previously been able to support acid and neutral grassland species.

A floodplain or open water habitat would be a suitable opportunity for this area, as it will enhance the current habitat for invertebrate and amphibian populations as well as providing additional water storage during flooding events and potentially reduce the frequency of flooding events that occur.

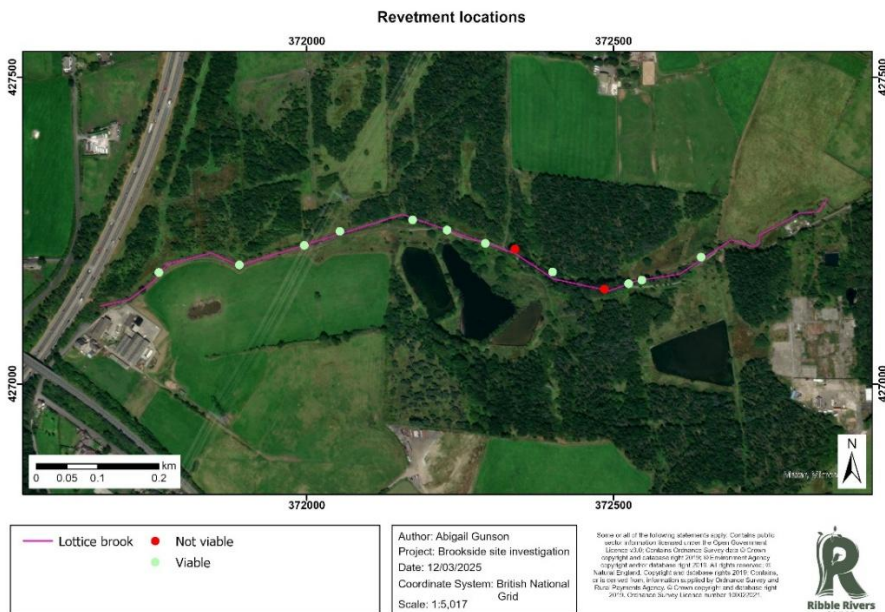
Figure 14 Map indicating revetment locations. Red locations are not an option for removal due to historical structure or mature tree

Several sections along Lottice brook are lined with stone wall and bed revetments that inhibits the natural shape and flow of the watercourse. Some of the sections of the watercourse would benefit from the removal of the revetments (see the provided map for opportunities for removal).

It should be noted that some locations will not be viable for revetment removal. There may be historical value or complications due to the presence of mature trees and culverts, so alternative actions may need to be considered in these areas.

The removal of these revetments would reconnect the watercourse with its associated floodplain and ultimately improve the functionality of the brook's natural flood management. It would also encourage the re-meandering of the brook into a more natural state and introduce some variability to the flow.

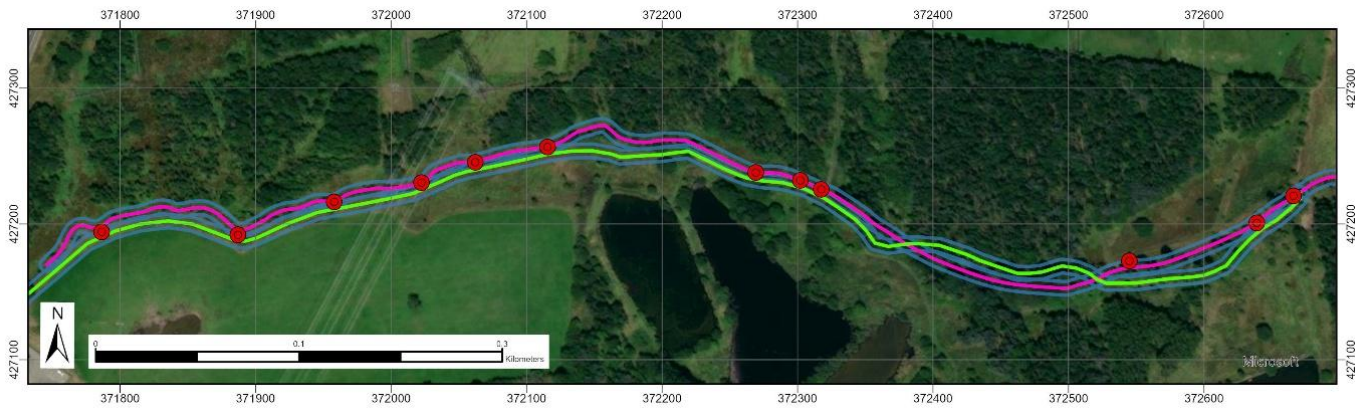
Figure 30 Map identifying locations where the banks of the brook have eroded within 5m of the footpath

At certain sections of the brook, the bank has eroded very close to the fence/path which poses a risk to the safety and stability of the main footpath. The below figure identifies locations where the distance between the brook and the footpath is 5 metres or less, and as such any further erosion could eat into the footpath.

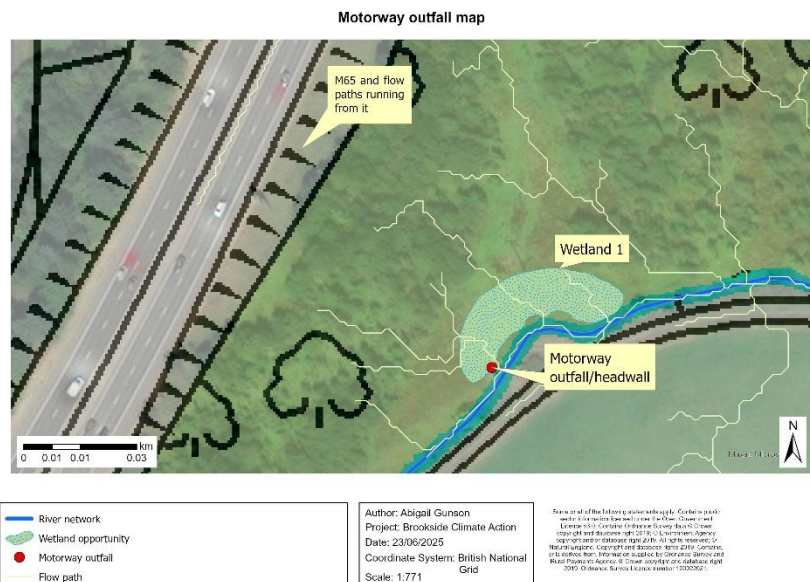
Figure 38 Flow paths intercepted by potential wetland

Figure 38 demonstrates the value of having a wetland in this location, run off from the motorway will reach the treatment wetland before it enters the watercourse, therefore reducing the volume of polluted water entering the brook.

Spoil from the works can be placed nearby, potentially as low bunds to encourage motorway run off through the wetland itself.

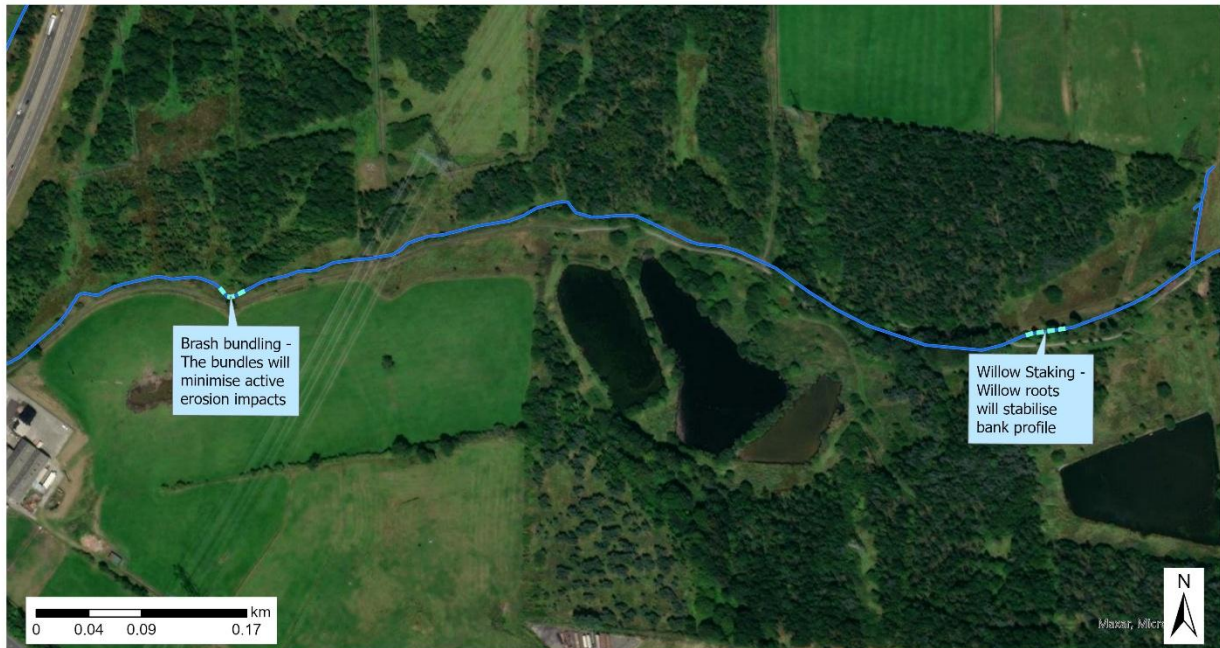
The marked areas are those identified to be locations where the right-hand bank of the brook has eroded or is actively eroding within 5m of the public footpath. The interventions suggested will mitigate any future erosion by stabilising the bank edges. It should be noted that large sections of the banks are colonised by Himalayan balsam, which will increase the risk of erosion due to their short roots which reduces the ability to hold the bank together during high flow events.
